OFFICIAL PUBLICATION OF THE AMERICAN SOCIETY OF MINING AND RECLAMATION

OPPORTUNITY PONDS WETLAND – A 500-ACRE WETLAND MITIGATION PROJECT

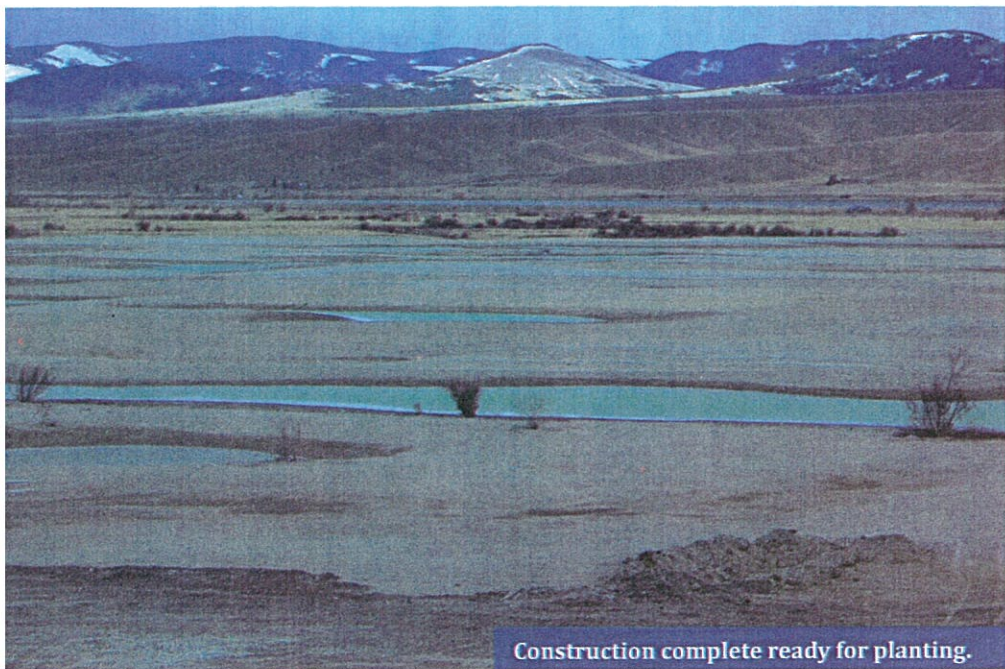
Construction complete ready for planting.

Capitalizing on the natural slope of the land and the groundwater gradient, contour dikes (e.g., cross-slope dikes) were constructed at key positions within the wetlands area to break the area into wetland cells. Islands and depressions were added to increase habitat diversity.

Fine-grained cover soil material was applied to provide a favorable growth medium. De-watering activities were stopped after construction and soil placement were completed, then the hydrology of the site was allowed to reach equilibrium. This gave us a better picture of what the final hydrology would be and aided in modifications of the planting plan to match that hydrology.

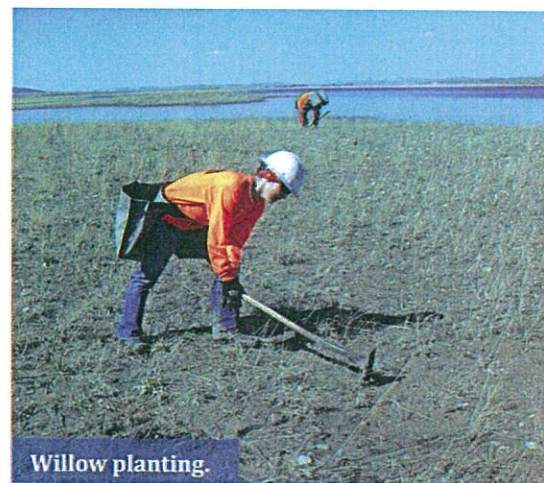
Willow planting.

- Tree planting hoes: Hand planting using "hoedads" was the most efficient method for willows and emergent plants that were grown in small containers. Hand planters could access the saturated and inundated areas, and the "hoedad" is well-designed for use with the 10 cubic inch containers.

Planting started in early May of each year with woody plants. It is beneficial to plant woody species before the spring flush of root growth. That way the plants are in the ground ready to take off as soon as the temperature warms. The planting crew hand planted willows in natural appearing bands in the lowest and most moist areas of the shrub zone. Deep rooted shrubs were planted in the appropriate hydrology for each species using the "Rotary Planter" or hand planting in holes excavated by power augers. We worked closely with the crew to assist them in proper placement of plants and any needed on-the-ground modifications to the planting plan.

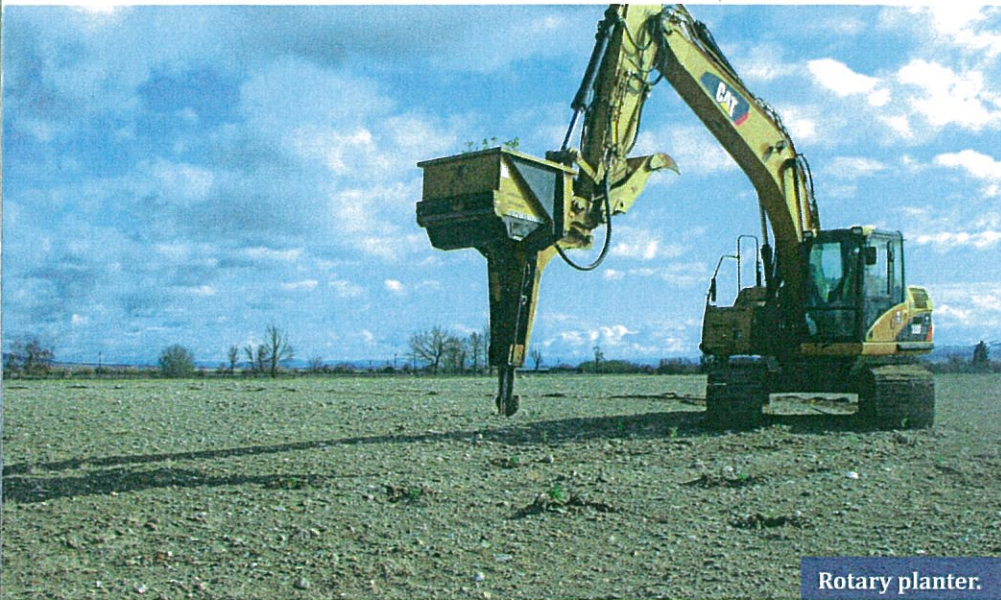
Rotary planter.

- Rotary Planter: This is an excavator-mounted planter that has a revolving magazine with a capacity of 50 plants and 3 rings. It is controlled by the operator so three different species can be loaded and the operator can choose the best species to plant in any specific spot. The planter is designed for use with deep rooted container plants. It can be used around the perimeter of the site where access does not require driving through saturated soil. Advantages of this technology are speed of planting and ability to dig holes with adequate depth for the deep rooted shrubs in rocky soils.

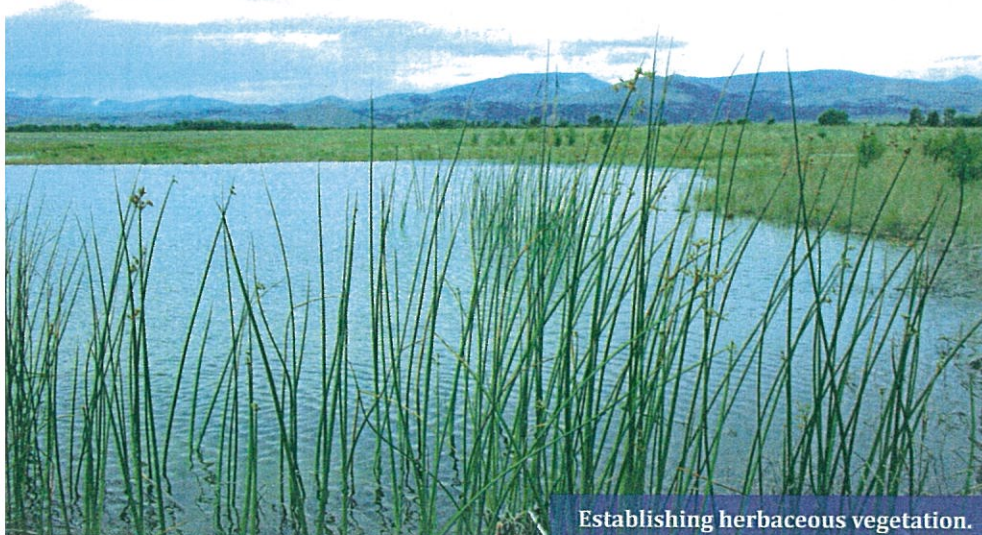
Establishing herbaceous vegetation.

The results of the monitoring show that herbaceous and bulrush plantings are rapidly spreading and increasing in density. Shrub and willow survival is 80% after two full growing seasons and plant densities are well within the long term shrub spacing goals. Many of the shrubs are also sprouting from the ground and increasing in density of stems per acre above the planted density. The created wetland area is seeing heavy use by waterfowl and big game. Ducks, geese, phalaropes, avocets and long billed curlews are all common. Whitetail deer and moose are using the site and even a mountain lion has been observed.
